Service Information Letter

SIL Number:	606-00083-016		
To:	Owners/Operators of Avidyne R9		
Subject:	Course Deviation Indicator (CDI) error when the leg into the Final Approach Fix (FAF) is not aligned with final approach course		
Purpose:	This Service Information Letter (SIL) advises owners and operators of Avidyne R9 of a condition in which incorrect deviations will be displayed		
Revision:	00	Date:	05/05/2015

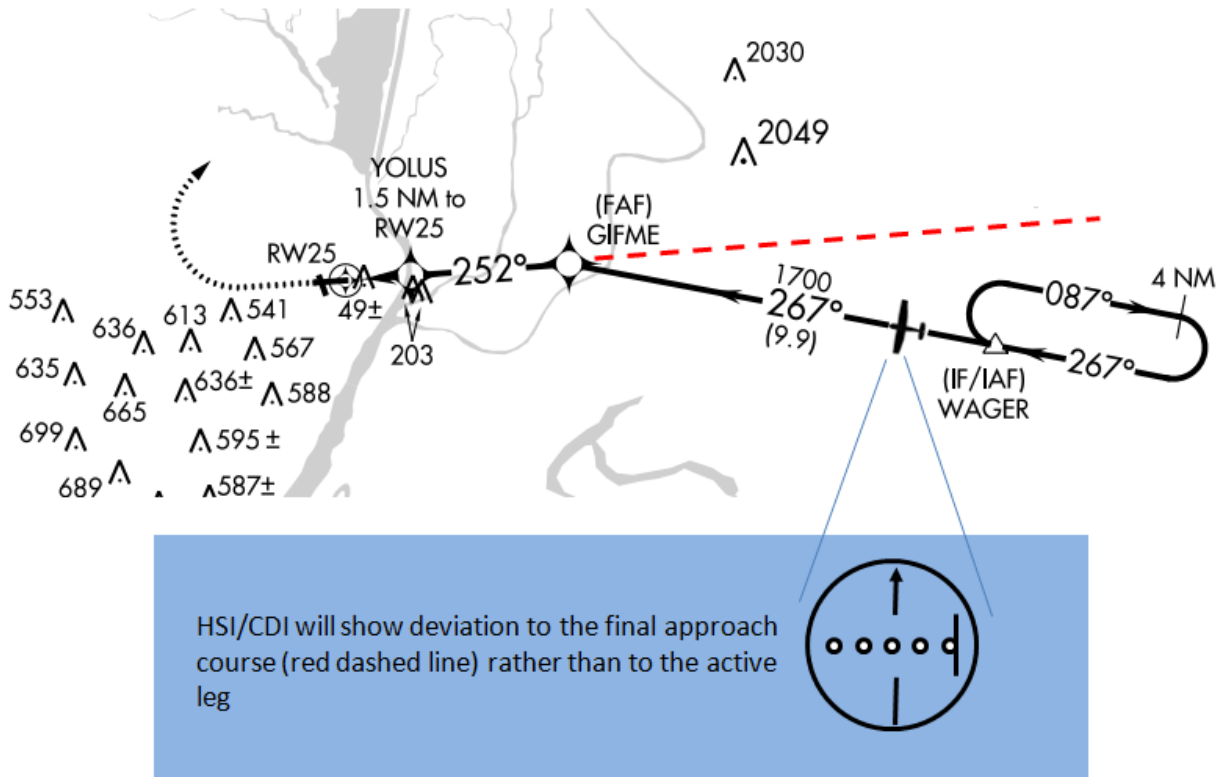
The condition occurs when flying certain SBAS approaches (WAAS- or EGNOS-based LNAV/VNAV, LP or LPV approaches), the leg to the Final Approach Fix (FAF) is active, and the leg to the FAF is not aligned with the final approach course (i.e. an angled entry to the FAF). This condition may exist as part of a published approach, but can also be induced by using the Direct-To function and the OBS function. In Release 9.3.1 (and earlier) software, the R9 will produce lateral deviations to the final approach course as soon as the leg to the FAF becomes active. Therefore, when the leg does not align with the final approach course, the CDI will show a deviation when, in fact, the aircraft is on the proper course for the active leg. See the picture below for an example representation of this issue:

This condition will occur on certain SBAS approaches (LNAV/VNAV, LP or LPV) when being flown via a published IAF or IF. It does not affect the use of Vectors-To-Final (VTF). When flying a non-SBAS (e.g. ILS, VOR) approach and when flying an SBAS approach via vectors-to-final, the R9 deviations are correct. No EGNOS SBAS approaches are affected as of nav data cycle 1505. (Note that EGNOS SBAS approaches are, however, affected by the issue if a Direct-to or OBS leg is initiated to the FAF.)

When the non-alignment condition exists, the pilot must **not** navigate using the published procedure data or course deviations shown on the IFD until the aircraft has reached the FAF.

Until this problem is resolved in software, the pilot must not select a published transition from the IFD FMS on any of these affected approaches unless it is a Vectors-To-Final (VTF) transition. Instead, the pilot must request and receive a VTF clearance and must activate the VTF transition in the IFD FMS.

The software change will be incorporated in software release 9.3.2. Avidyne requires all owner/operators of the R9 to update the software to Release 9.3.2 when it is available to resolve this issue.
